FIELD INVESTIGATION REPORT

Site Name: 9524 and 9540 Niagara Falls Boulevard, Niagara Falls, Niagara County

Date(s) of Visit: October 2 - 4, 2006

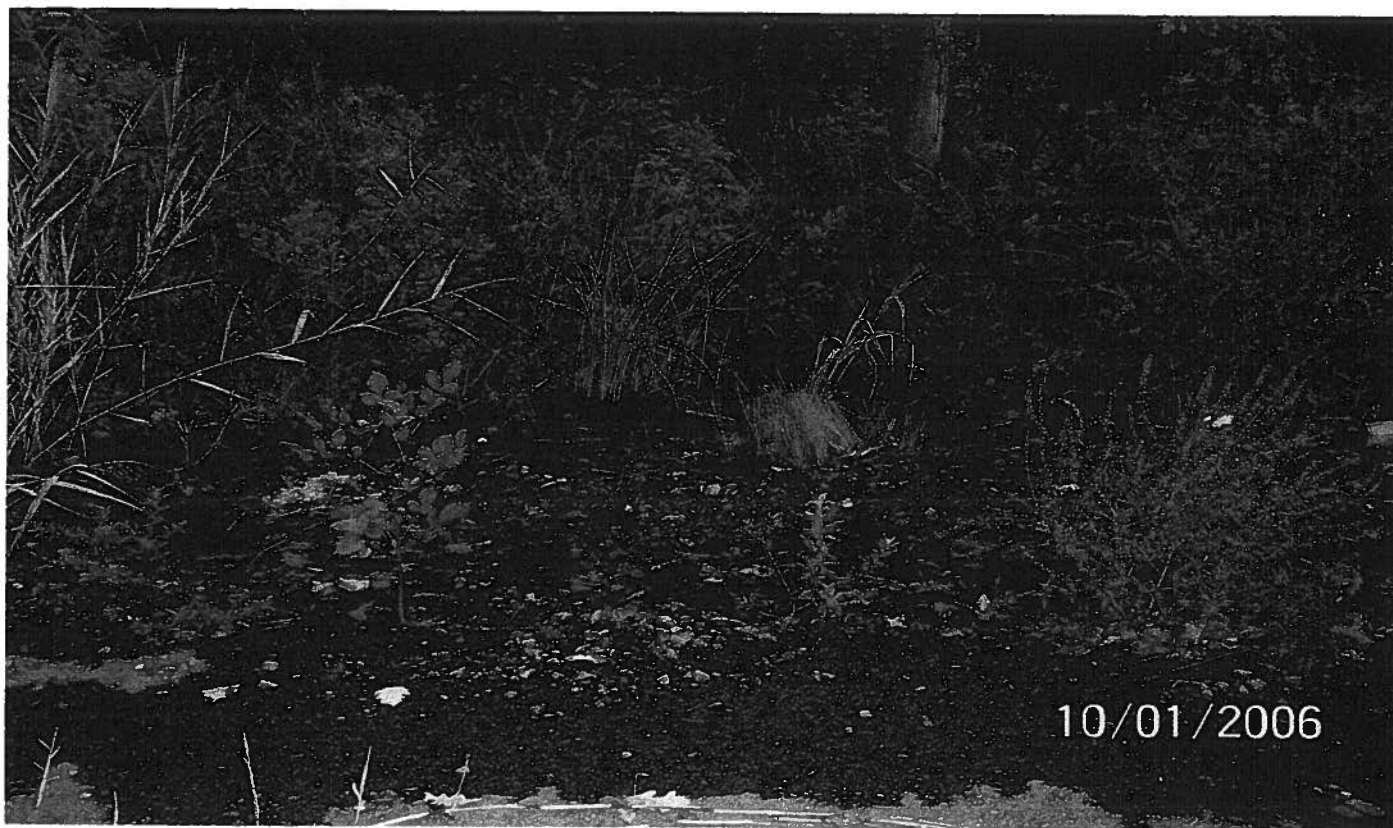
Marshy area behind 9524 Niagara Falls Boulevard.

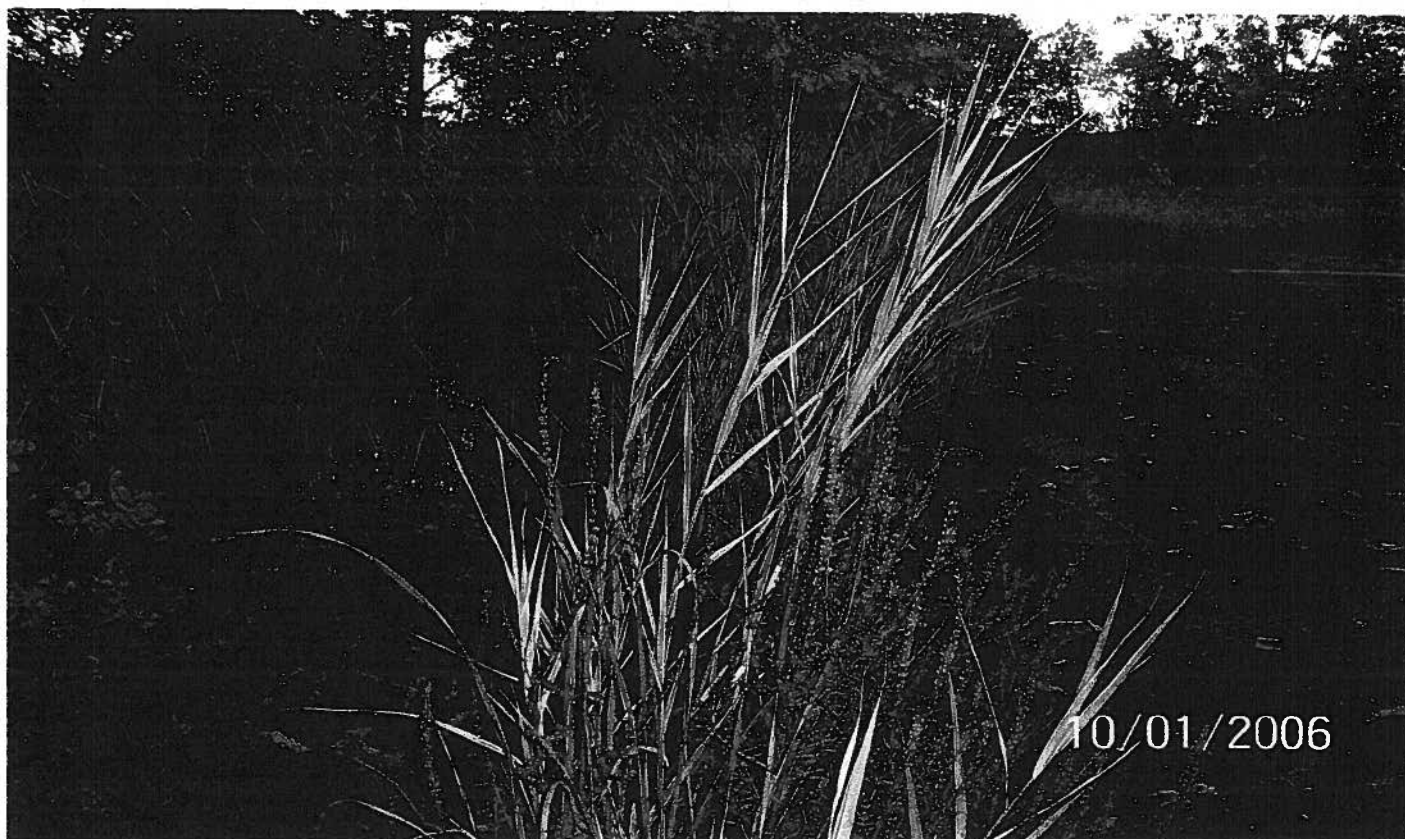
Rear parking lot at 9524 NFB. Note poor condition of the asphalt.

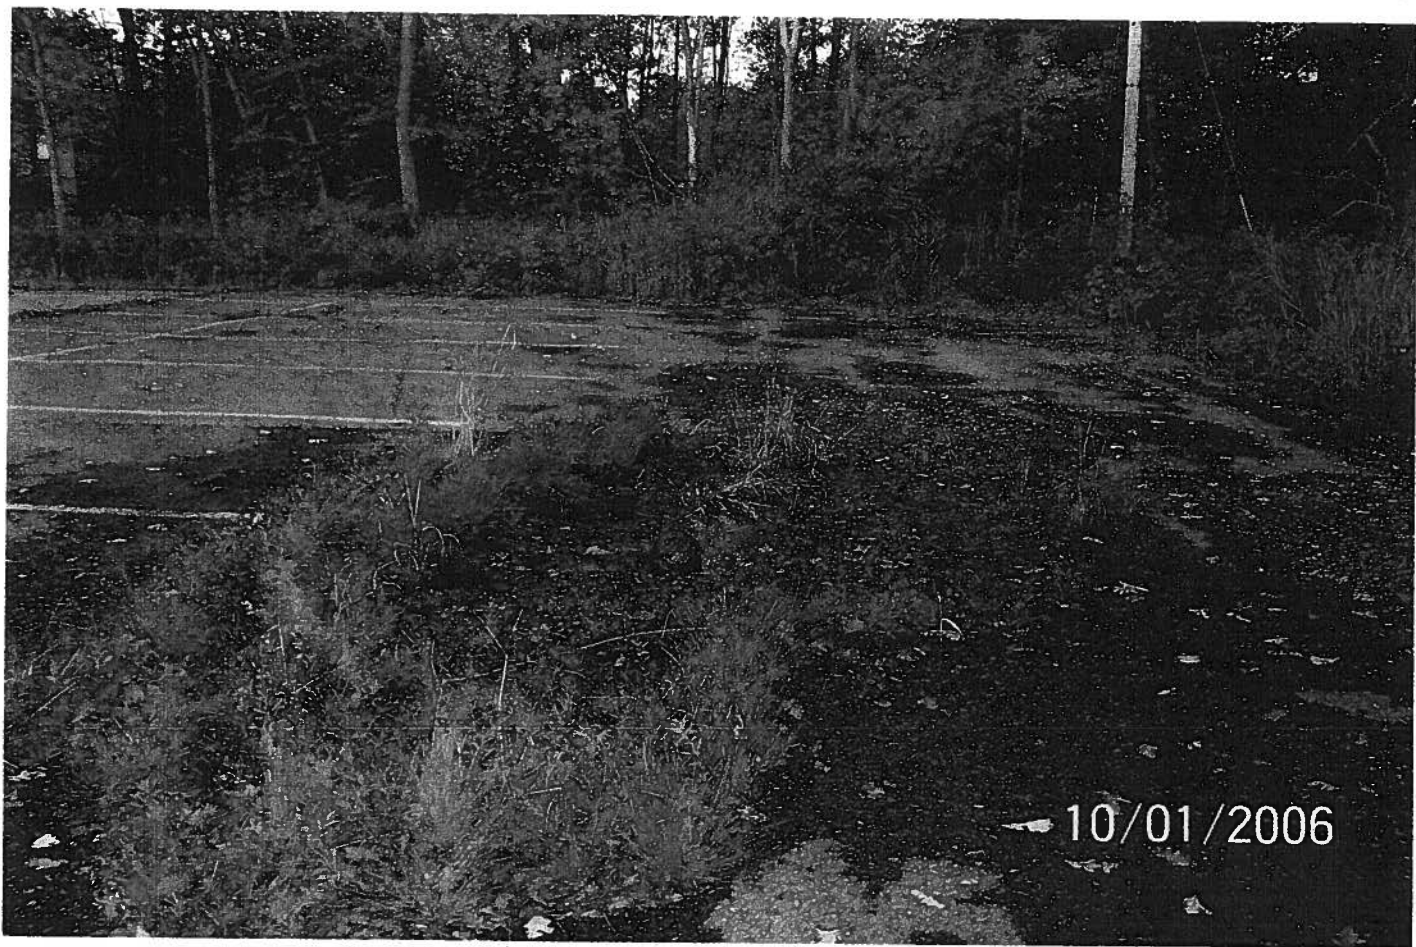
Rear parking lot at 9524 NFB looking toward the western edge of the parking lot. Note the poor condition. Readings here are in the 10-15 uR/hr range.

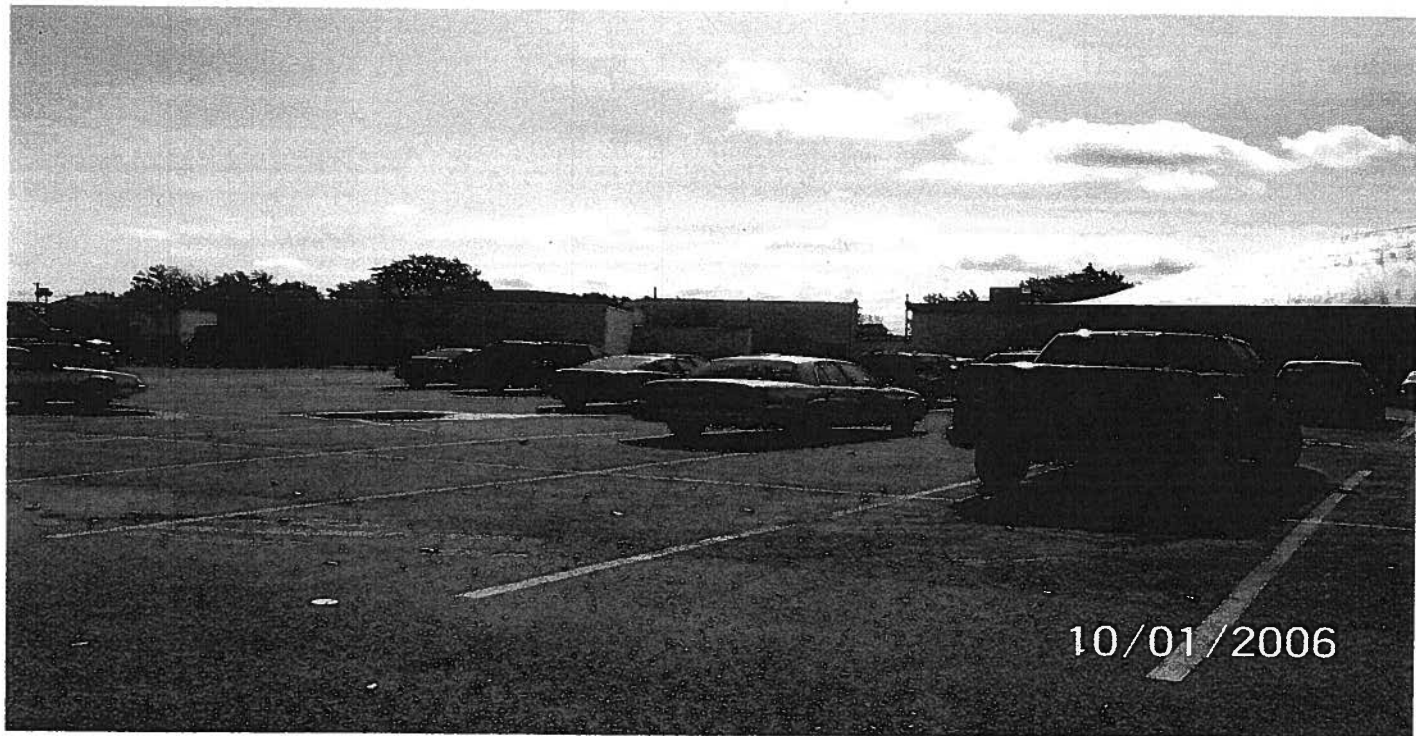
Parking lot behind 9540 and 9524 NFB. Building on the left is Dunn Tire, on the right is Rapid Bowling.

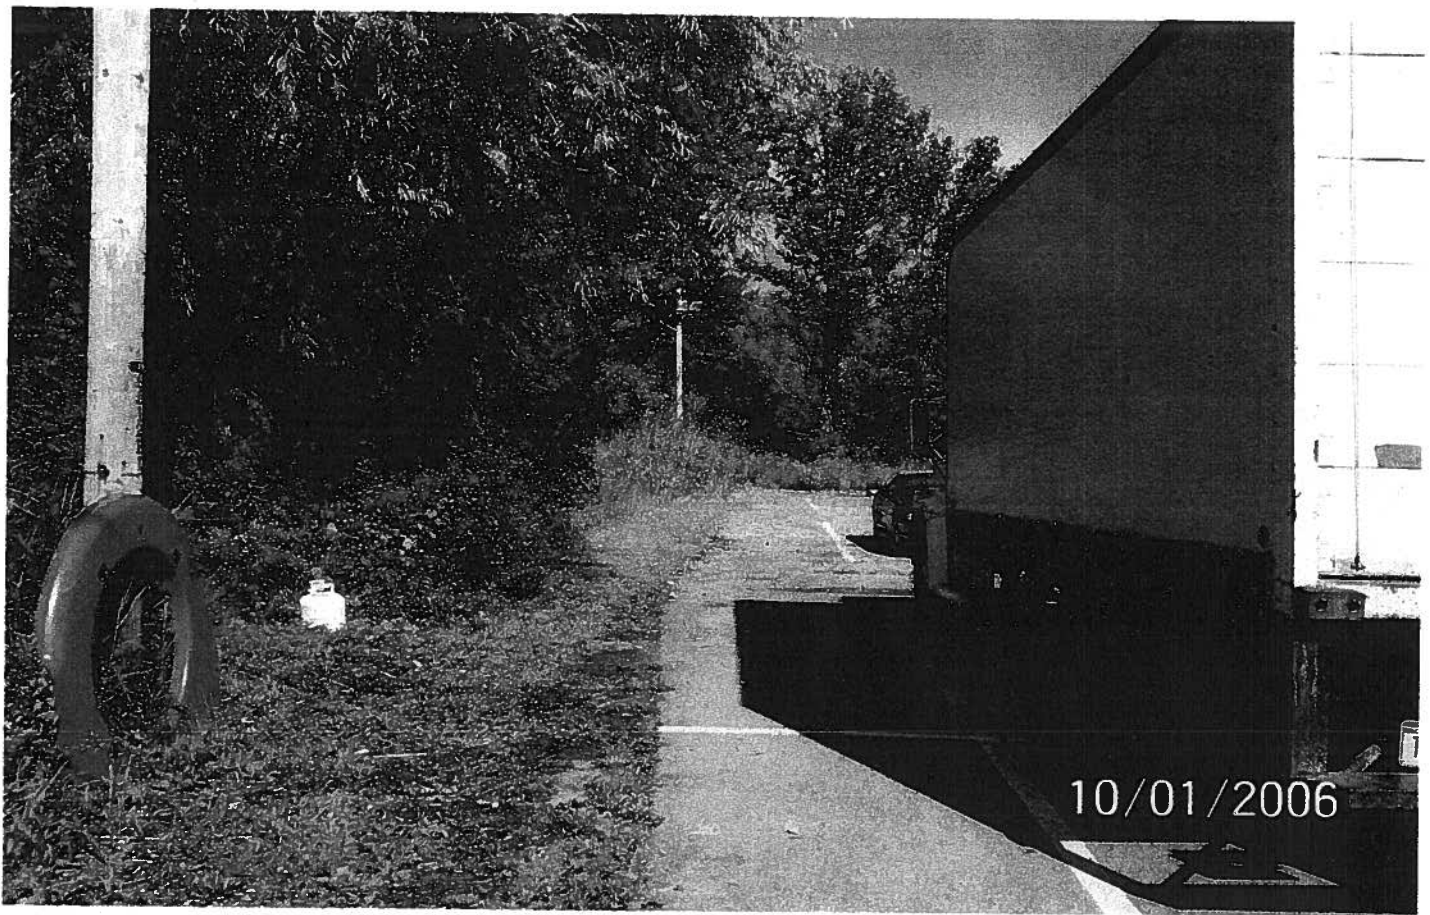
While surveying the rear lot, elevated readings were discovered in the grassy area abutting the parking lot on the hotel side. Several spot contact readings were in excess of 400 uR/hr. Due to time constraints and inclement weather, this area was not surveyed in its entirety.

Rear parking lot of Rapid Bowl looking toward the marshy area. Grassy area on the left exhibited elevated readings in spots. A thorough survey was not done here.

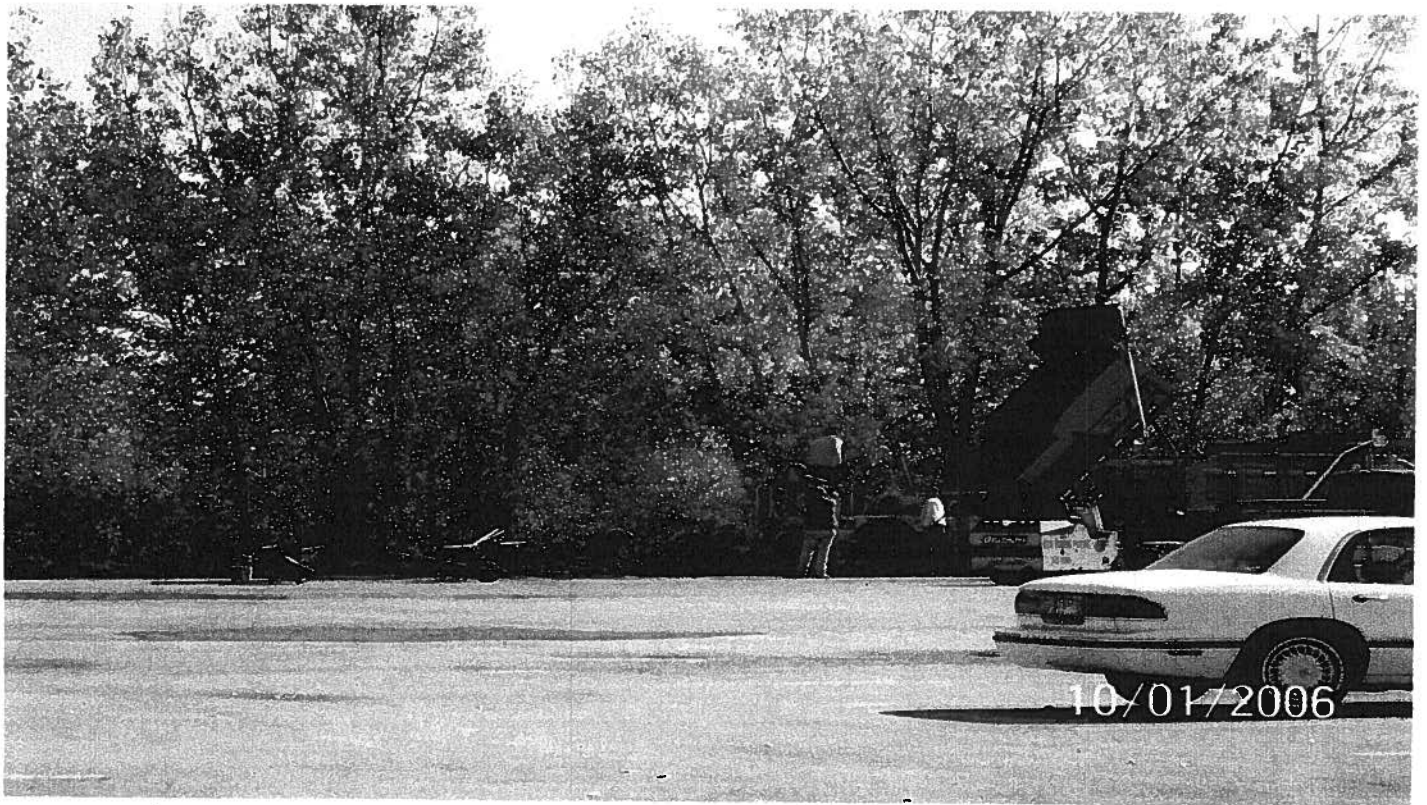
Paving crew repaving ten foot swath behind Dunn Tire.

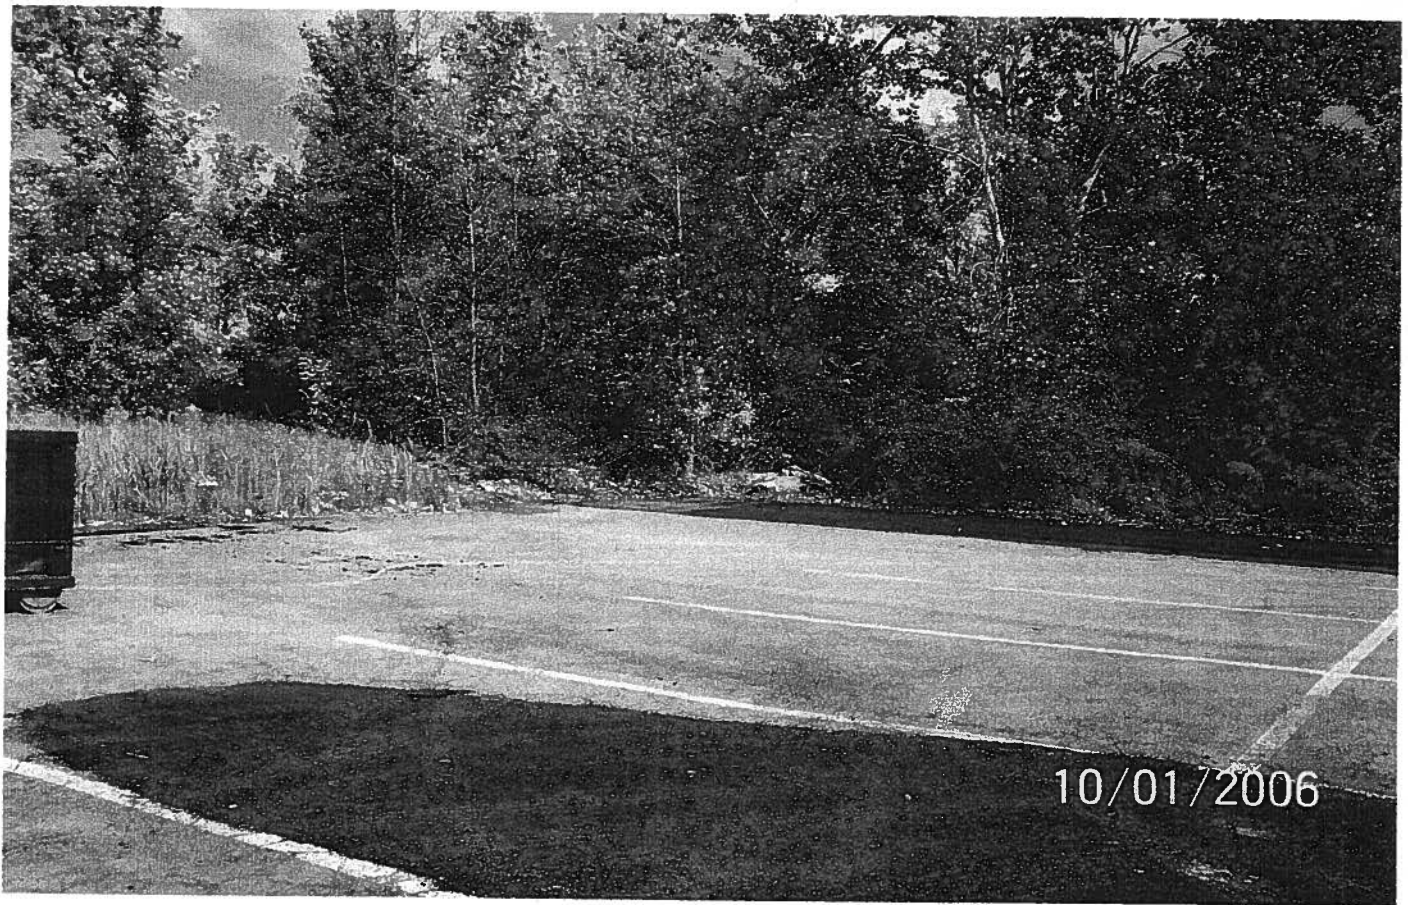
In the midst of the above operation, it was observed the ten foot swath of original asphalt had been scraped prior to paving. Material not previously observed was evident along the entire length of the swath including a large pile of debris (approximately 25 feet x 13 feet x 4 ½ feet) at the end of the swath in the marshy area. The material consisted of soil, blacktop, and loose slag. The material was now mixed /covering other debris along this swath including wooden pallets and a pile of shingles. Initial survey of this area with the Exploranium showed numerous spots in excess of 550 uR/hr. **Exemption 7(C)** stated the area had been scraped with the front bucket of a backhoe. The actual date is unknown but it happened sometime between our last visit on September 21, 2006 and today.

Newly paved area behind Dunn Tire. Note debris pile at the end of the swath. "Newly paved" area in the foreground happened previous to this evolution.

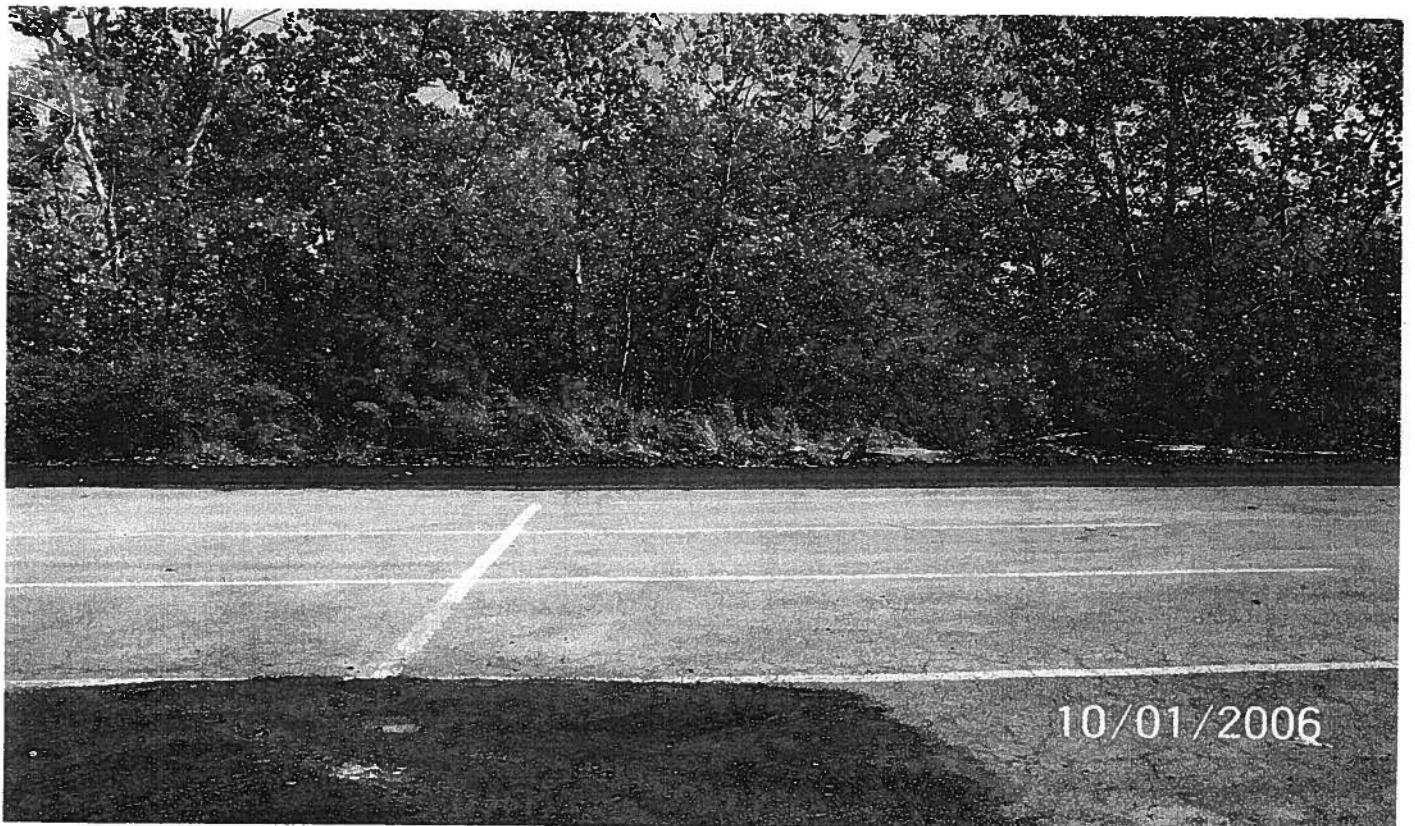
Another shot of the newly paved swath. Note the debris piles along the edge from the scraping of the area prior to paving.

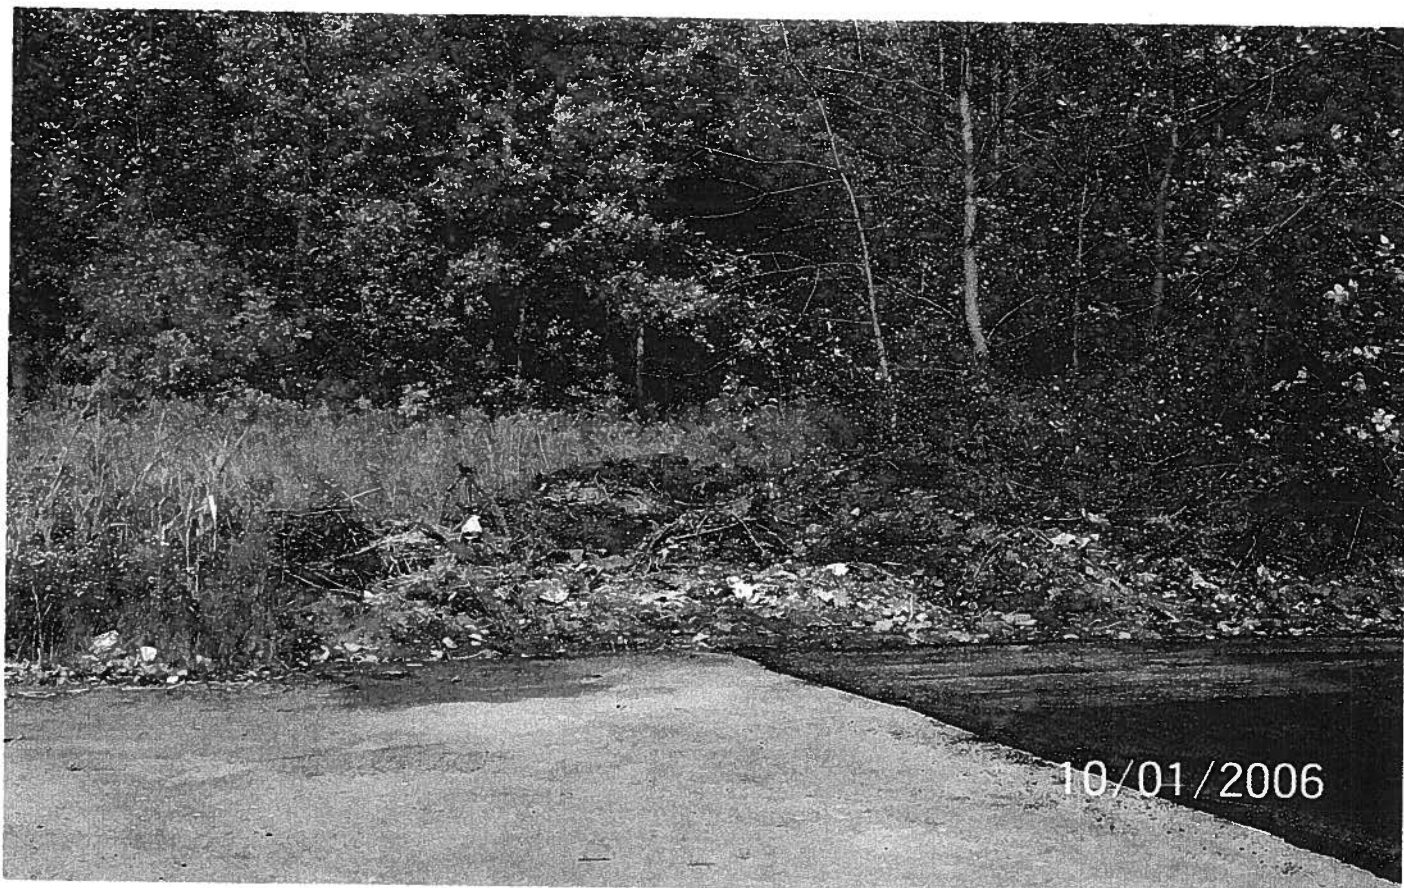
Debris pile at the end of the newly paved swath behind Dunn Tire. Exposed slag is evident resulting in dose rate readings in excess of 500 uR/hr.

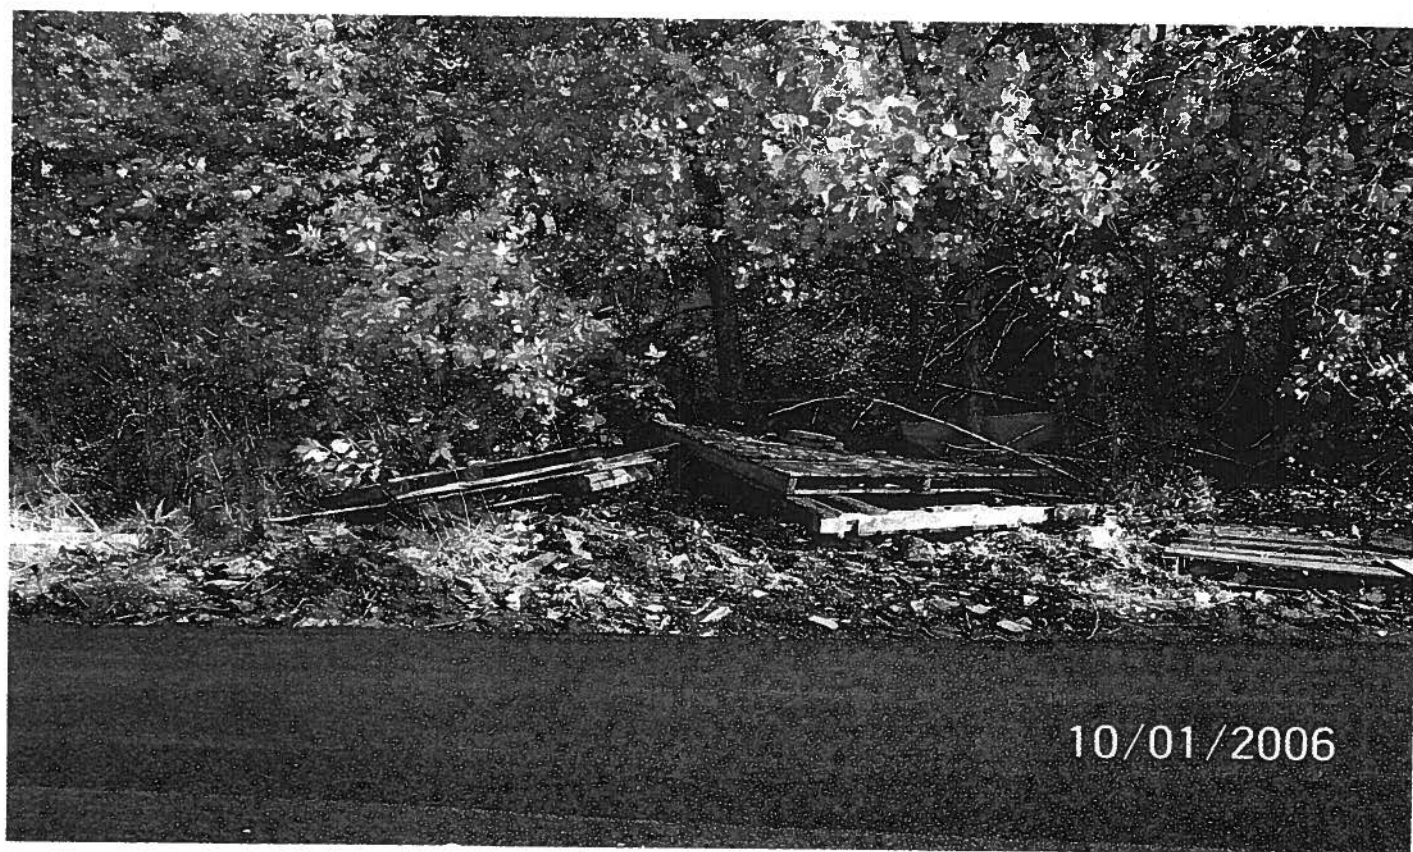
Pallets and other debris scattered along the entire edge of the 10' x 100' swath. Readings here exceed 500 uR/hr.

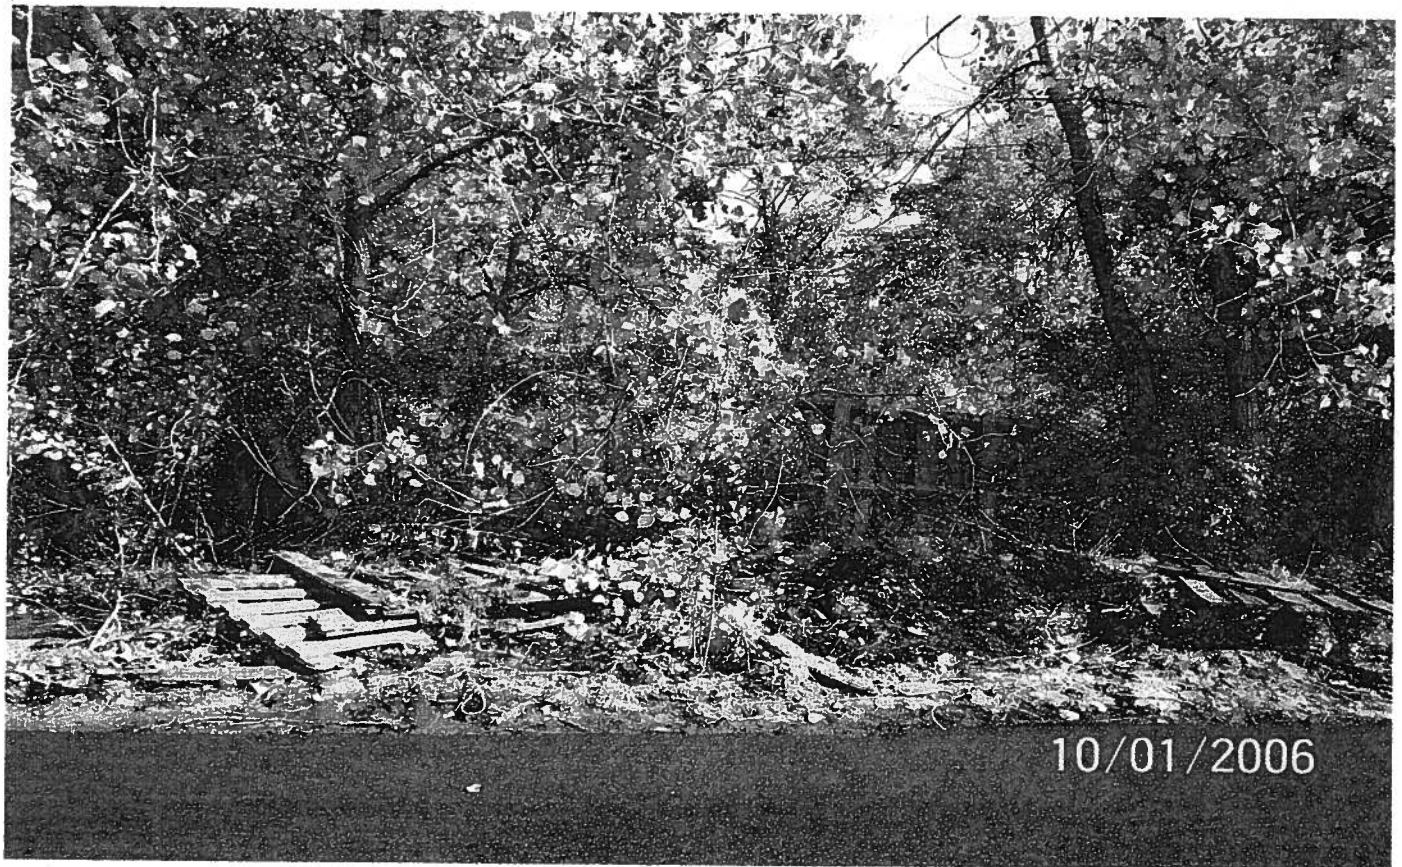
More debris and pallets scattered along the newly paved swath.

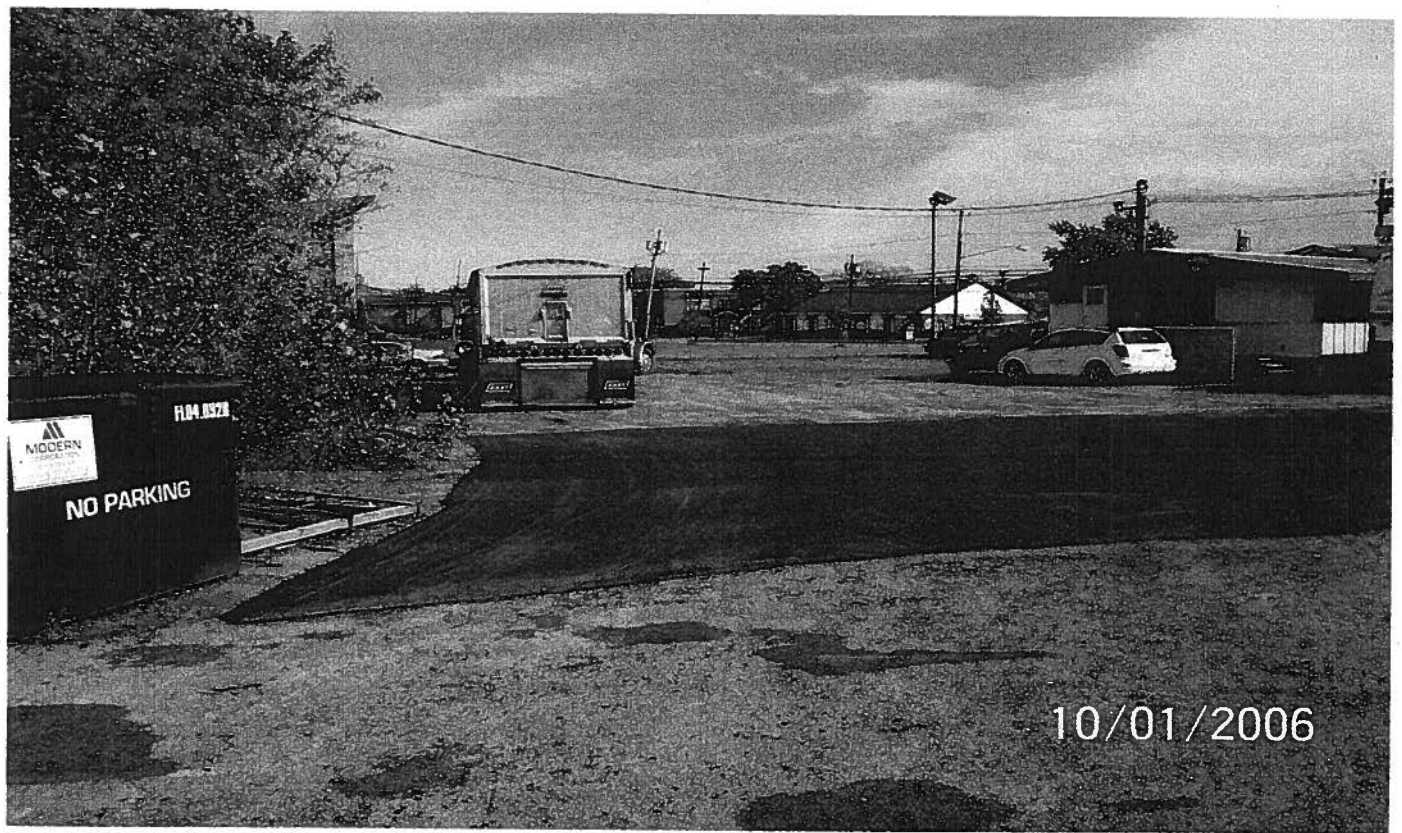
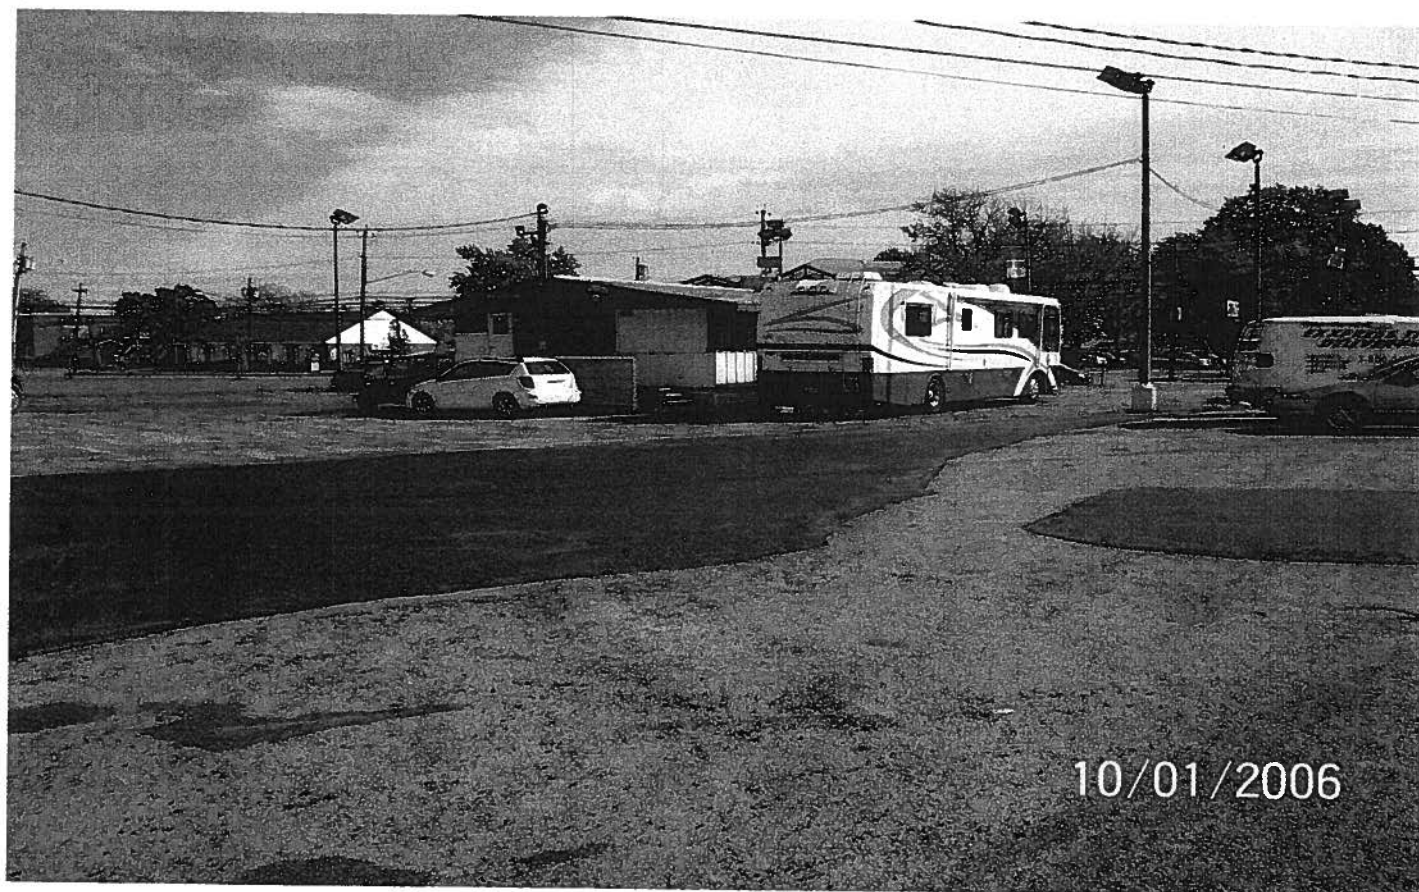
Newly paved triangular shaped area between Dunn Tire and the used car dealer lot.

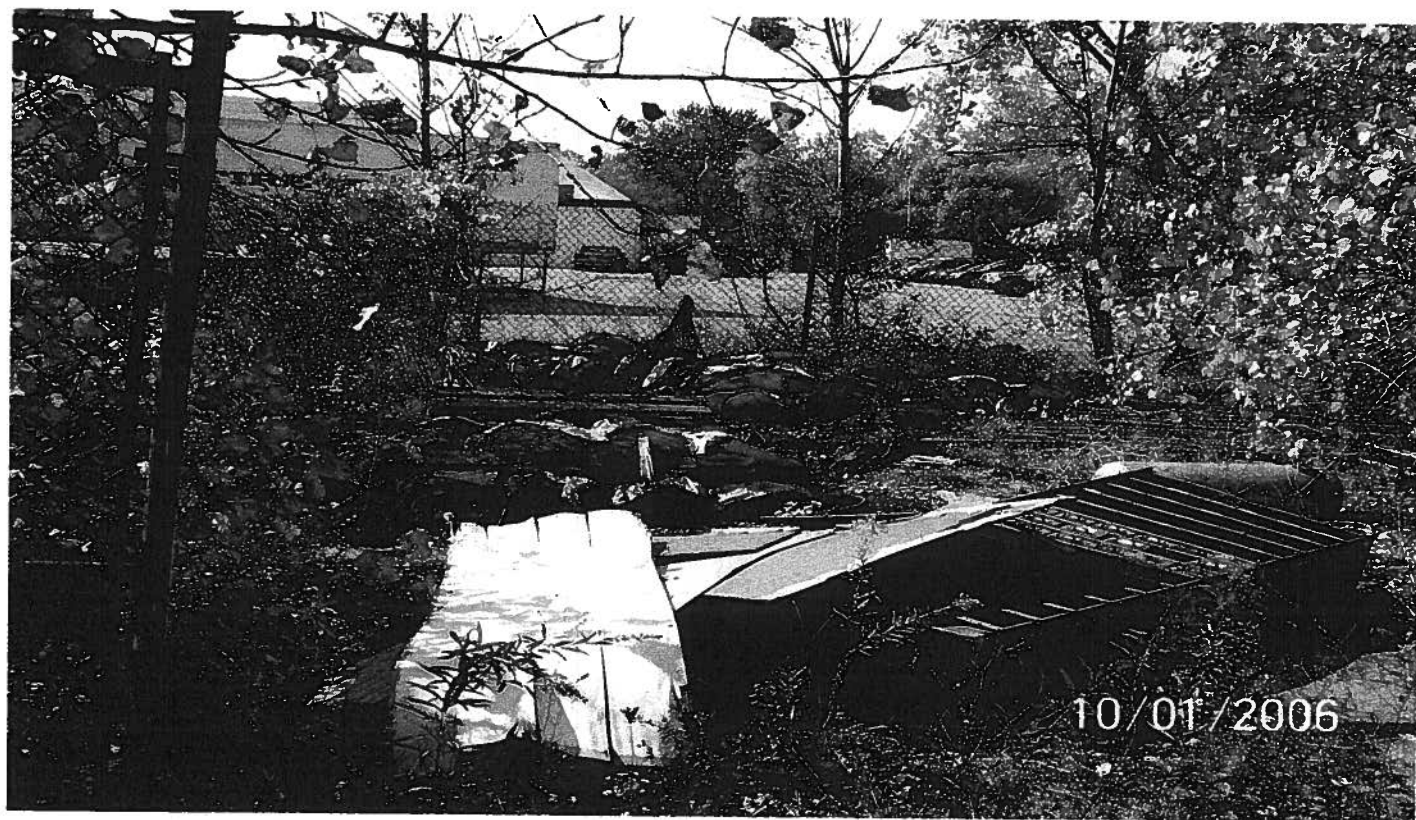
There is a fenced area directly behind the used car lot measuring 53 feet wide by 179 feet in length. There is a 12 foot wide gated opening just off the used car lot. This area is blacktopped for the most part, although in very poor condition. Trees and scrub brush are also present. There is debris scattered and piled throughout including tires, pallets, car parts, ruptured tar pails and garbage. Waist height readings range from 200 - 450 uR/hr in the accessible areas. Contact readings here are the highest observed on site ranging from 450 - 750 uR/hr. This area was not surveyed 100%.

Debris located in fenced area behind the used car dealer. Dose rate readings inside the fenced area range from 200 – 750 $\mu\text{R/hr}$.

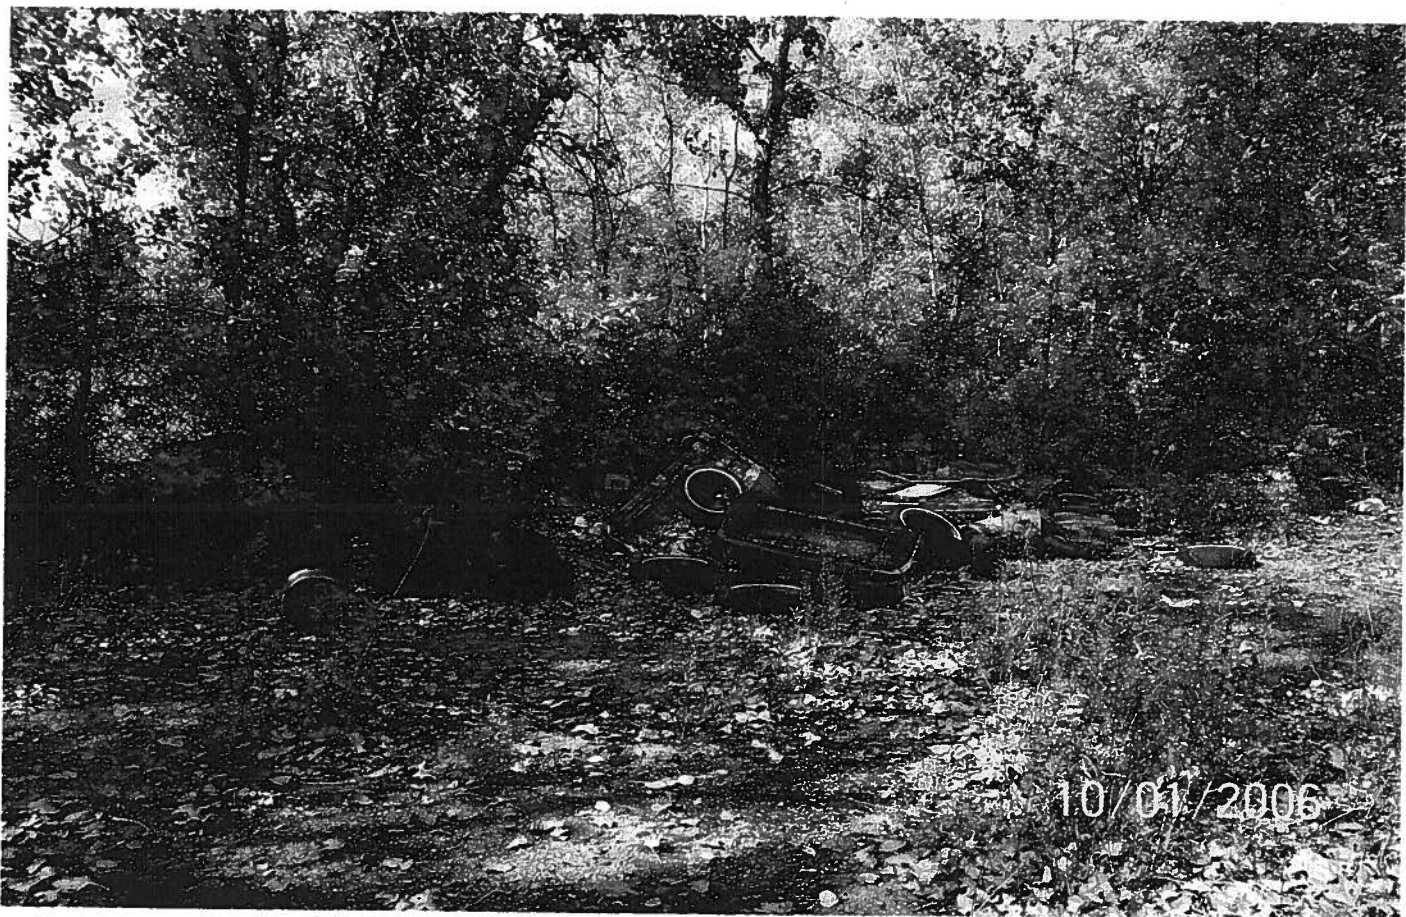
More debris in the fenced area. This area is blacktopped also and may be the original surface as placed in the early 60's. Note poor condition and the brush growing up through the cracks in the surface.

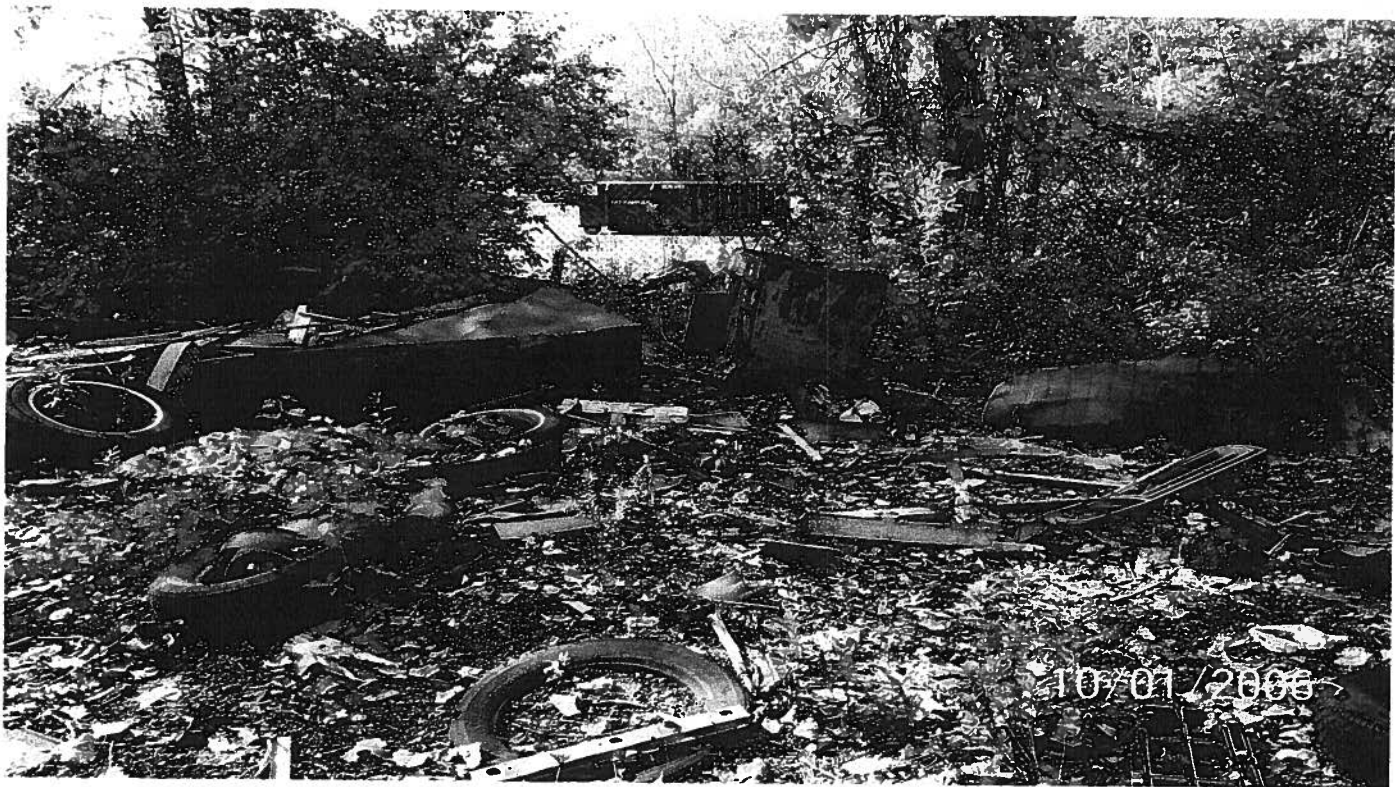
More debris inside the fenced area.

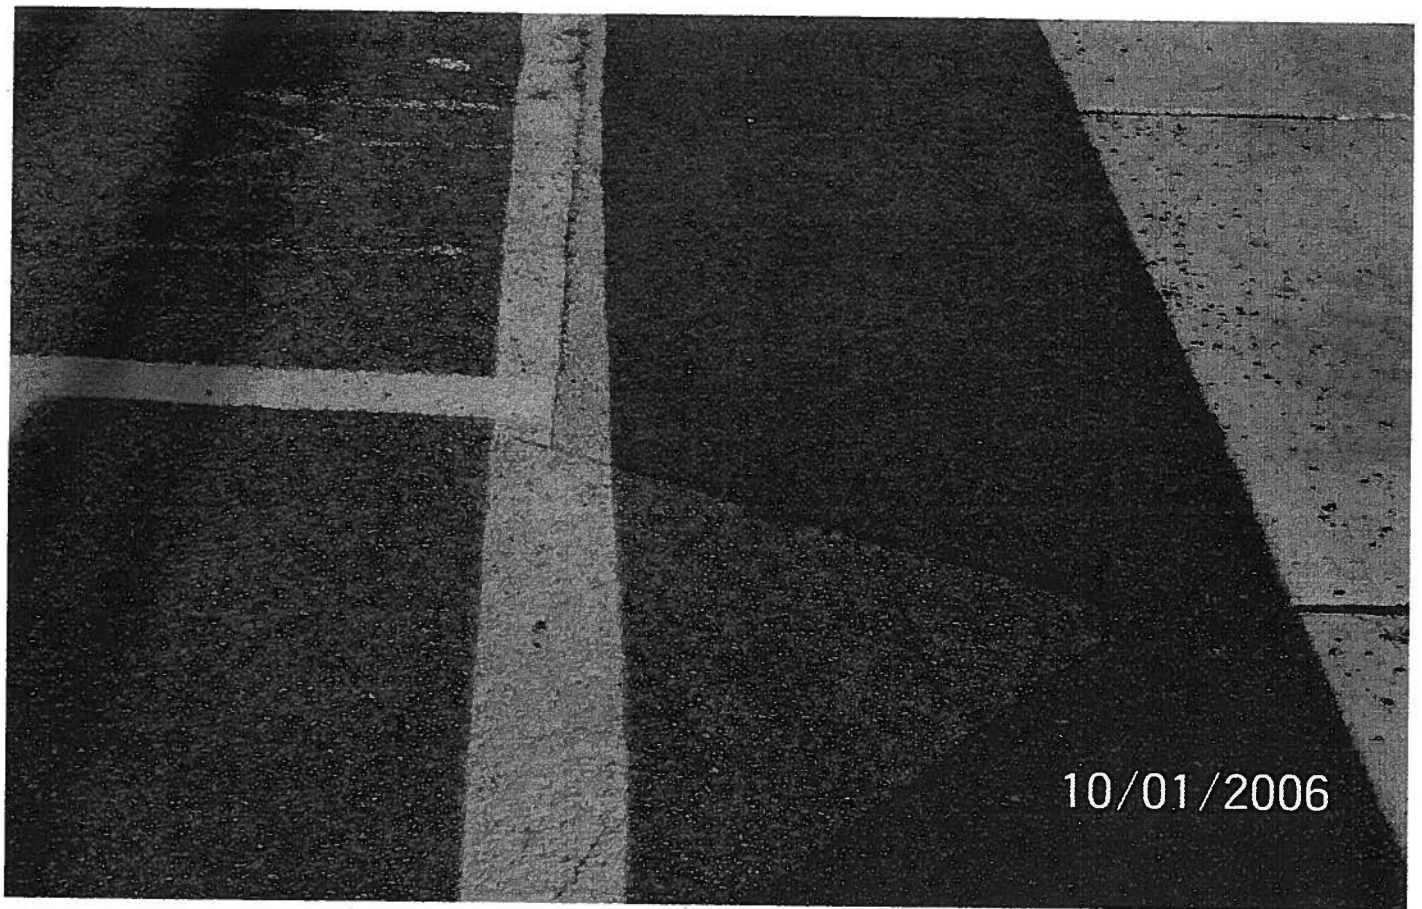
Front parking lot of Rapid Bowl. Note separation between "old" and "new" asphalt, Elevated readings were found on contact with the old but not with the new surface. Sidewalk on the right runs alongside NFB.

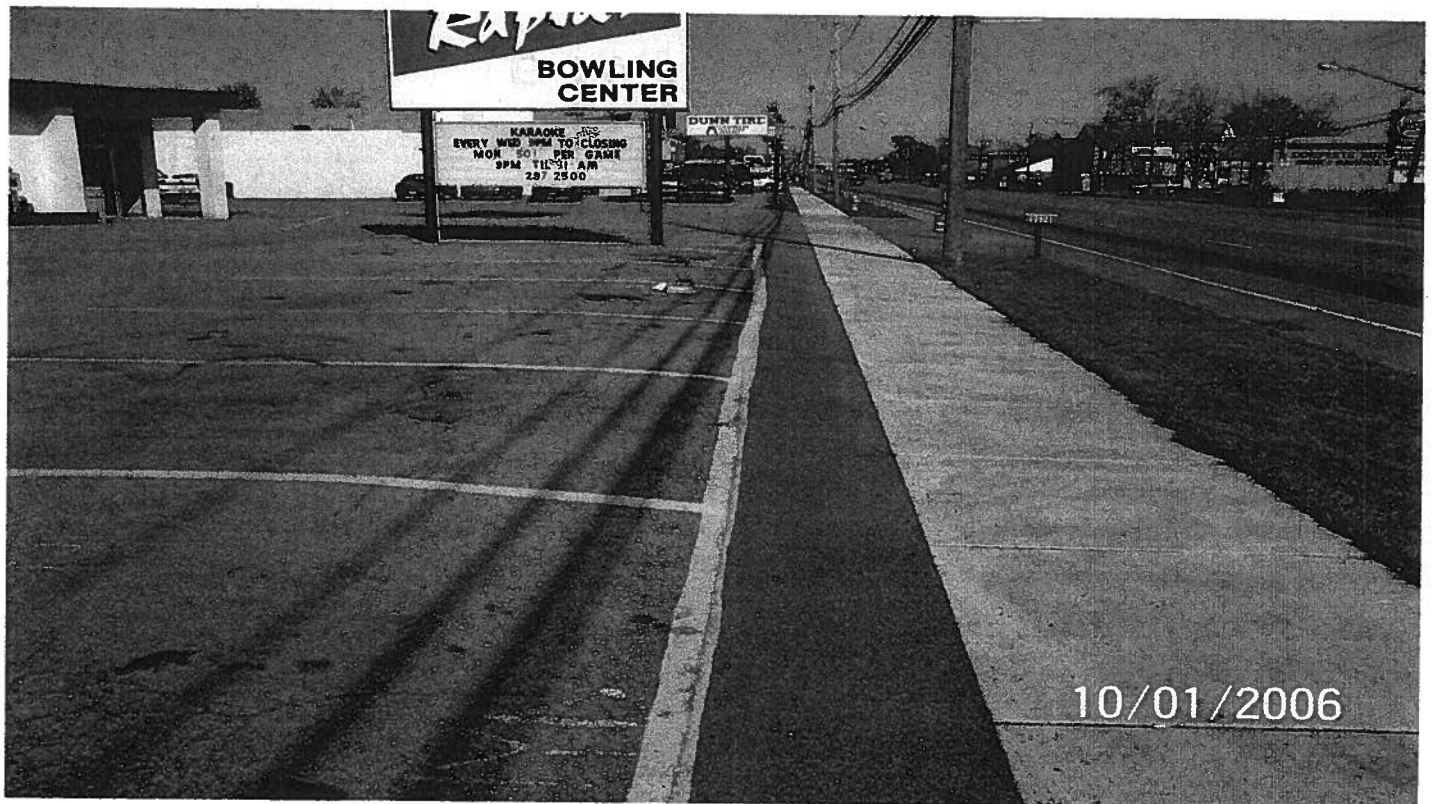
View of Rapid Boel front parking area and sidewalk, with Dunn Tire in the background. Note separation of asphalt along perpendicular yellow painted line.
